MaxLite cites inaccuracies in James Industry response to UL public notice

In the interest of public safety, MaxLite is addressing several important points absent from a James Industry press release about the UL warning on that company's Direct Replacement Dual-Mode LED Tube (Model Number ZY-T8-18W1200 BIXX).

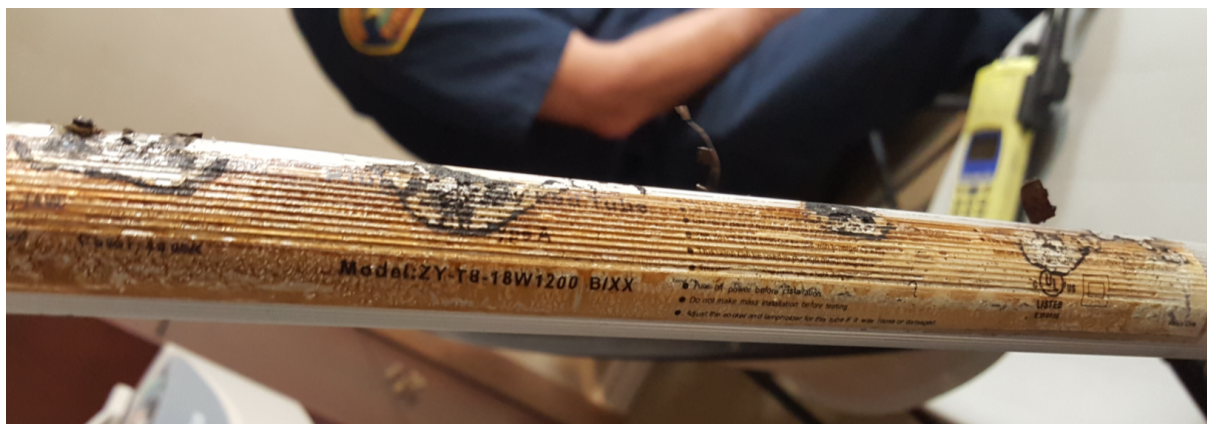
On October 8, 2016, a fire erupted at the four-story Four Seasons Homeowners Association building, located in Beverly Hills, California. The fire and resulting smoke condition caused damage throughout the building and its cause is currently under investigation. The fire began in a James Industries' Direct Replacement Dual-Mode LED Tube (Model Number ZY-T8-18W1200 BIXX).

James Industry Dual-Mode T-8 Replacement Tube Model No. ZY-T8-18W1200 BIXX in which the HOA fire began (cause under investigation).

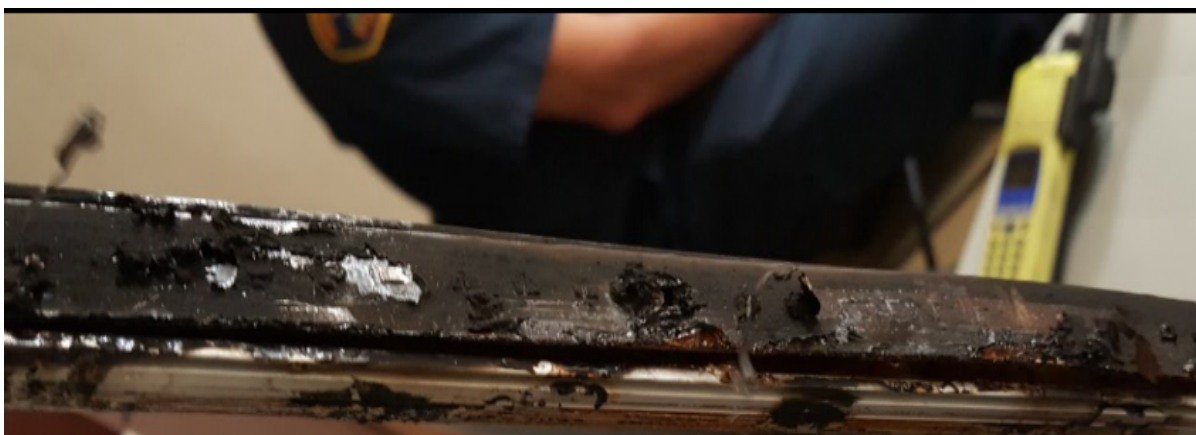
Another view of the James Industry Tube Model NO. ZY-T8-18W1200 BIXX.
